FACILITY CONDITION ASSESSMENT NARRATIVE

SUN PRAIRIE PUBLIC LIBRARY

MAY 2018

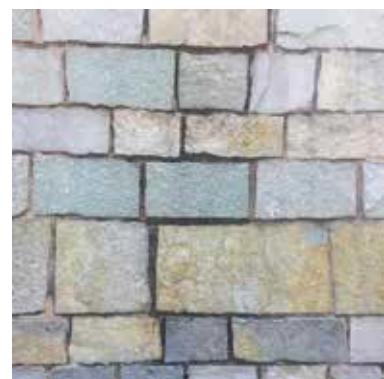
The mix of materials on the exterior create a complex aesthetic but there is little visible evidence of differential movement. There is some discoloration on the stone and mortar, which is mostly due to weathering and natural dirt build up. Cleaning the stones with as mild a solution as possible is a good way to both keep them looking good, but also to keep them safe from deteriorating due to oil and dirt residue. There are minimal instances of rust visible at masonry cracks; this

should be repaired. There are a few instances around the chimney where mortar is missing or deteriorated; this should be repointed.

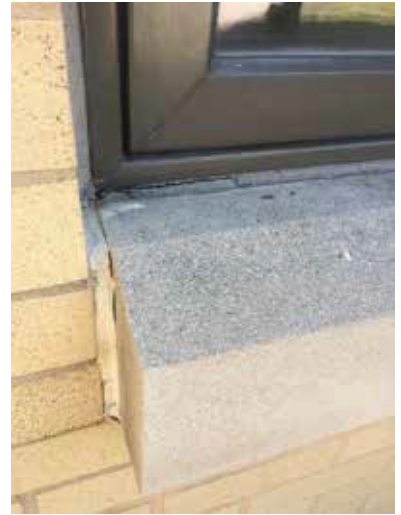
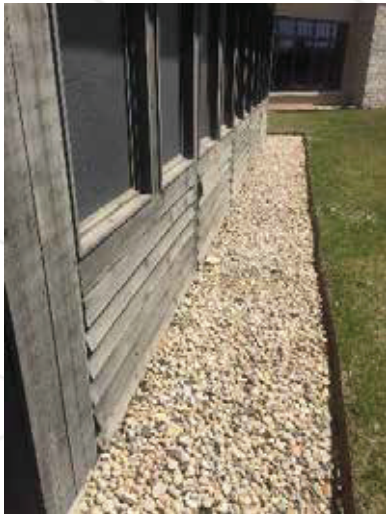
Sealant around windows and doors is cracking and contracting. It is at the end of its expected life and should be replaced at all exterior locations. There are some locations of pipe penetrations that are not sealed at the exterior, allowing entrance to pests and moisture; these should be sealed.

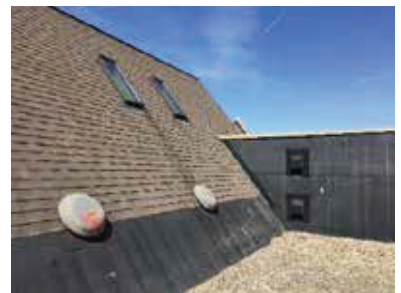
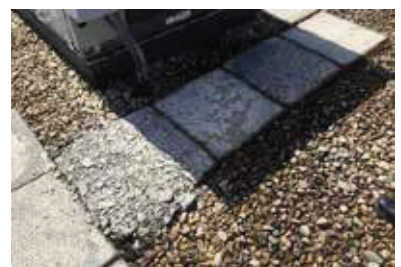
The existing roof is a mix of forms and materials. The gables are asphalt shingles, cement tile roofing, copper standing seam roofing, with copper flashing and stone copings. The low slope roof quadrants that house mechanical equipment are covered with black EPDM roof membrane. The gable roofing portions are weathering well, but the roof membrane is nearing the end of its life expectancy. The sealant seams are contracting and in need of replacement. There are some punctures in the membrane that could allow water infiltration; these should be sealed. Exposed roof termination bars should be re-sealed. The walkway pavers are deteriorating and spalling, which is interrupting the water path to the roof drains and allowing water to pond. It is expected that fixes will help maintain the roof for a few

more years whereupon it should be replaced. A non-ballasted system is recommended with a light-colored membrane with a long warranty.

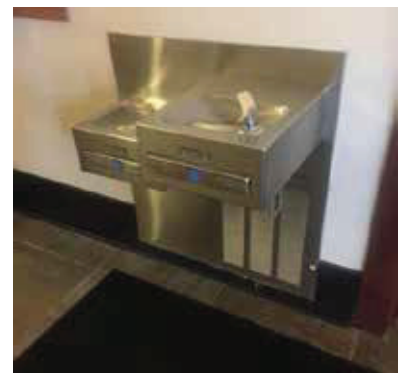
All publicly accessed water fountains are required to be installed in pairs at two mounting heights to allow for occupants of different reach ranges to use them. The current drinking fountains at the main entrance and the children's area are in pairs, but they are mounted in the path of egress travel, protruding too far from the face of the wall into the corridor. The drinking fountain in the Media Center is not accessible.

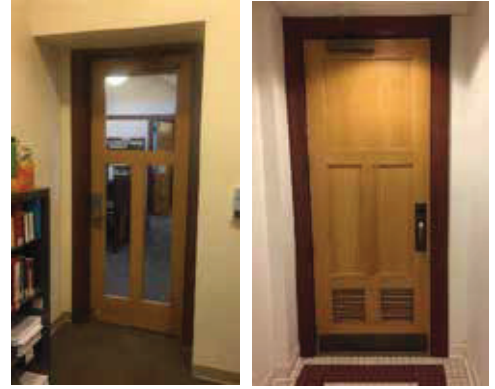
Generally, all doors in use by the public must have 1'-0" of clearance beside the door on the push side and 1'-6" on the pull side. There are instances of insufficient clearances adjacent to doors, specifically in the bathrooms and the door exiting the staff area. Proper clear space is also required where walls are greater than 8-inches thick. The exterior walls and acoustically-rated walls have door frames that are justified to the exterior plane of the wall, resulting in insufficient clearances at doors in the community room, the exterior, and the back entrance to the media center.

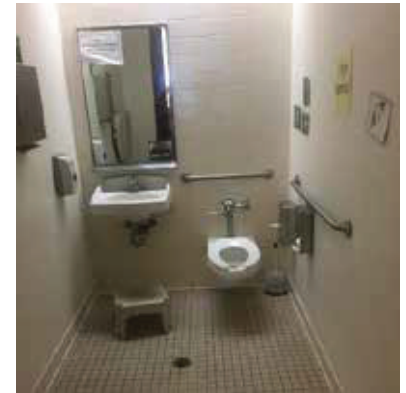
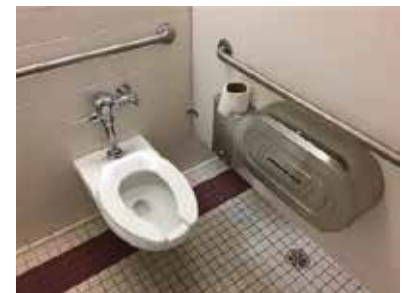
None of the six toilet rooms are fully accessible. Accessibility is not only the large toilet stall, but also includes the door clearances, grab bar locations, clear space in front of the sink, maneuvering spaces, and toilet accessories. The public bathrooms do not have the proper door clearances, insufficient space is provided between the stalls and the edge of the vanity, are missing a grab bar installed vertically above the 42" bar on the wall parallel to the toilet. The toilet paper dispenser protrudes too far into the accessible stall clear area. The staff toilet rooms are not required to be accessible since they are not open to the public. But, they do not have sufficient space around the toilet. The media center toilet room and youth toilet room are too small, without the proper clear space, improper grab bar sizes, and toilet accessories mounted too high. Shrouds are also required at piping below the sink.

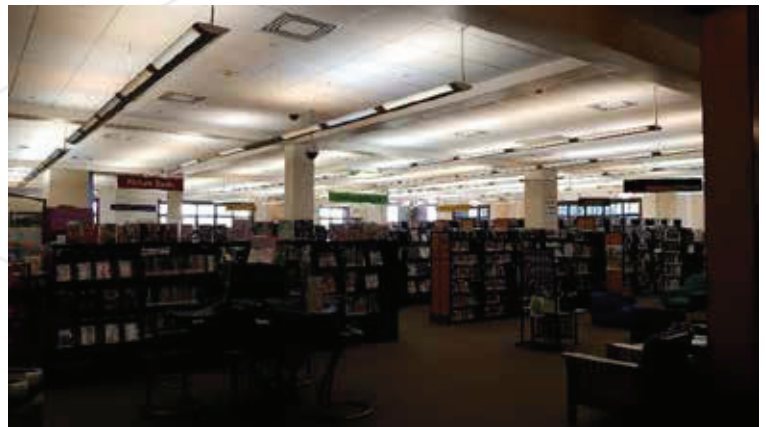
Stacks - Suspended direct/indirect fluorescent with T8 lamps. Fixtures are in good condition. Illumination levels within the stacks is appropriate and consistent with current illumination standards. Lamp color temperature (CCT) is varied unintendedly and very noticeable against the ceiling. It is likely the case of those replacing the lamps being unaware of the differences associated with CCT values. [Photo Right]

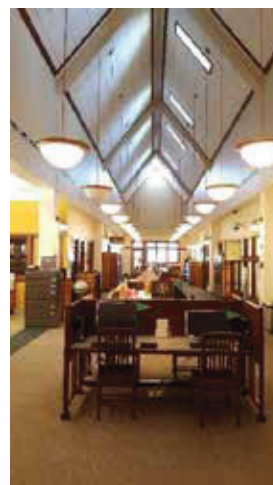
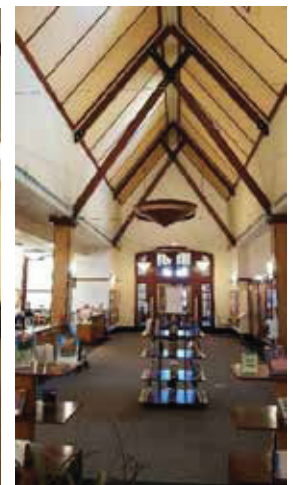
Public Circulation - A mixture of suspended direct/indirect bowl style pendants, decorative wall sconces and a custom catenary style vessel to indirectly illuminate the exposed beam structure. The layered lighting approach and decorative fixture seems to meet the spaces needs along the entry axis corridor which extends from the front door to the fire place. The suspended bowls in spaces perpendicular to the entry axis appear dated and do not provide sufficient illumination. These areas include the reference seating carrels and the children's area. These particular areas are also a concern of the library staff. [Photos Right]
