SUN PRAIRIE PUBLIC LIBRARY

FACILITY CONDITION ASSESSMENT NARRATIVE - DRAFT
SUN PRAIRIE PUBLIC LIBRARY
MAY 2018

ARCHITECTURAL ASSESSMENT

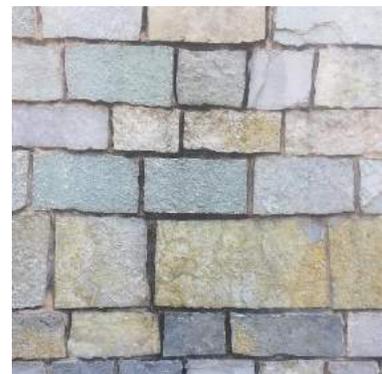
The mix of materials on the exterior create a complex aesthetic but there is little visible evidence of differential movement. There is some discoloration on the stone and mortar, which is mostly due to weathering and natural dirt build up. Cleaning the stones with as mild a solution as possible is a good way to both keep them looking good, but also to keep them safe from deteriorating due to oil and dirt residue. There are minimal instances of rust visible at masonry cracks; this

should be repaired. There are a few instances around the chimney where mortar is missing or deteriorated; this should be repointed.

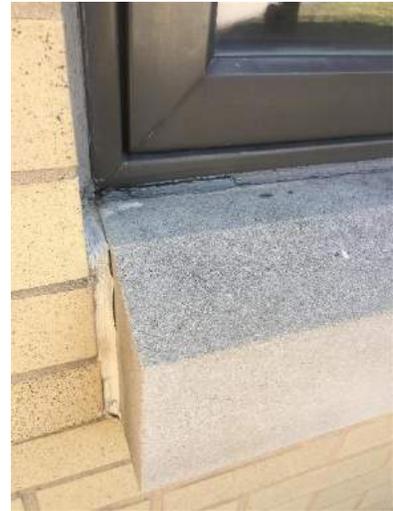
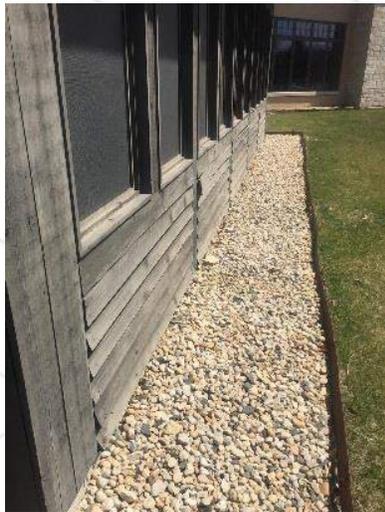
Sealant around windows and doors is cracking and contracting. It is at the end of its expected life and should be replaced at all exterior locations. There are some locations of pipe penetrations that are not sealed at the exterior, allowing entrance to pests and moisture; these should be sealed.

The porches provided on the west and east sides of the building have cedar siding and a cedar-trimmed fascia. This has weathered and has started cupping, with nails sticking out. The boards should be re-fastened and replaced if necessary. The stain finish has also deteriorated due to exterior exposure and should be reapplied. If these porches were to be occupied year-round, new siding material should be provided, they would require little structural modification, and should be evaluated for egress and code compliance.

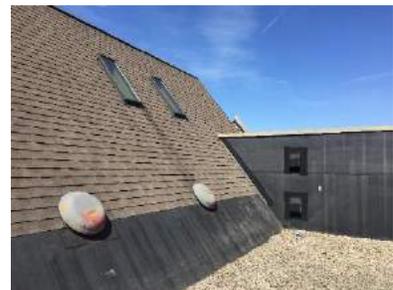
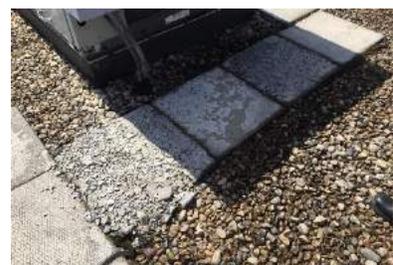
The existing roof is a mix of forms and materials. The gables are asphalt shingles, cement tile roofing, copper standing seam roofing, with copper flashing and stone copings. The low slope roof quadrants that house mechanical equipment are covered with black EPDM roof membrane. The gable roofing portions are weathering well, but the roof membrane is nearing the end of its life expectancy. The sealant seams are contracting and in need of replacement. There are some punctures in the membrane that could allow water infiltration; these should be sealed. Exposed roof termination bars should be re-sealed. The walkway pavers are deteriorating and spalling, which is interrupting the water path to the roof drains and allowing water to pond. It is expected that fixes will help maintain the roof for a few

more years whereupon it should be replaced. A non-ballasted system is recommended with a light-colored membrane with a long warranty.

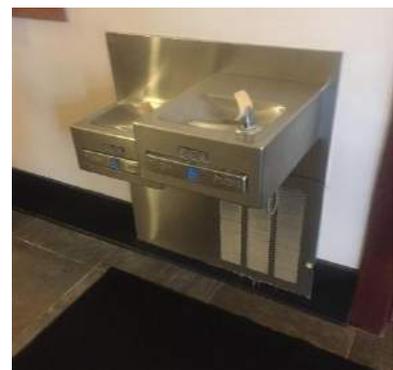
All publicly accessed water fountains are required to be installed in pairs at two mounting heights to allow for occupants of different reach ranges to use them. The current drinking fountains at the main entrance and the children's area are in pairs, but they are mounted in the path of egress travel, protruding too far from the face of the wall into the corridor. The drinking fountain in the Media Center is not accessible.

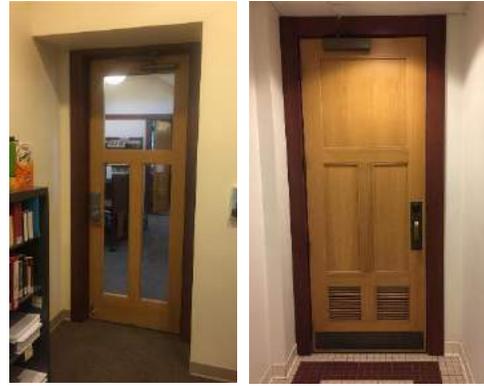
Generally, all doors in use by the public must have 1'-0" of clearance beside the door on the push side and 1'-6" on the pull side. There are instances of insufficient clearances adjacent to doors, specifically in the bathrooms and the door exiting the staff area. Proper clear space is also required where walls are greater than 8-inches thick. The exterior walls and acoustically-rated walls have door frames that are justified to the exterior plane of the wall, resulting in insufficient clearances at doors in the community room, the exterior, and the back entrance to the media center.

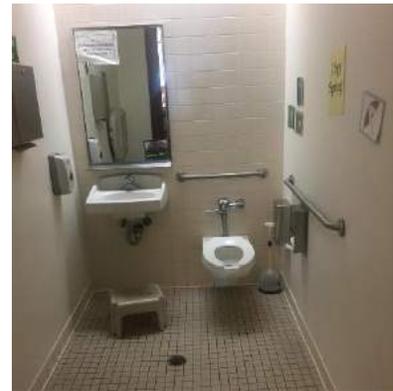
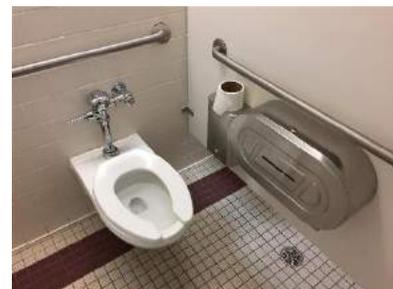
None of the six toilet rooms are fully accessible. Accessibility is not only the large toilet stall, but also includes the door clearances, grab bar locations, clear space in front of the sink, maneuvering spaces, and toilet accessories. The public bathrooms do not have the proper door clearances, insufficient space is provided between the stalls and the edge of the vanity, are missing a grab bar installed vertically above the 42" bar on the wall parallel to the toilet. The toilet paper dispenser protrudes too far into the accessible stall clear area. The staff toilet rooms are not required to be accessible since they are not open to the public. But, they do not have sufficient space around the toilet. The media center toilet room and youth toilet room are too small, without the proper clear space, improper grab bar sizes, and toilet accessories mounted too high. Shrouds are also required at piping below the sink.

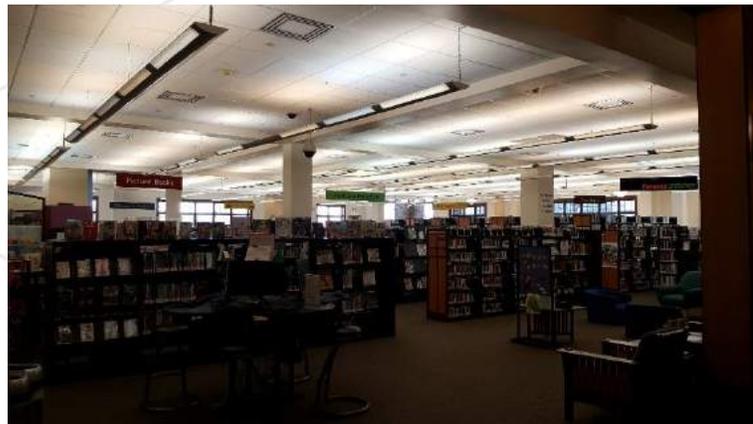
Stacks – Suspended direct/indirect fluorescent with T8 lamps. Fixtures are in good condition. Illumination levels within the stacks is appropriate and consistent with current illumination standards. Lamp color temperature (CCT) is varied unintendedly and very noticeable against the ceiling. It is likely the case of those replacing the lamps being unaware of the differences associated with CCT values. [Photo Right]

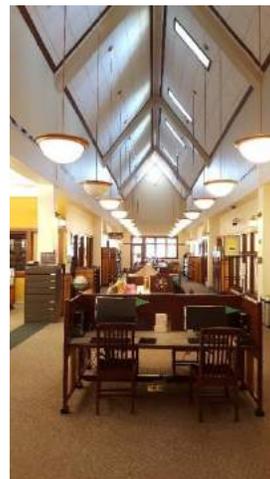
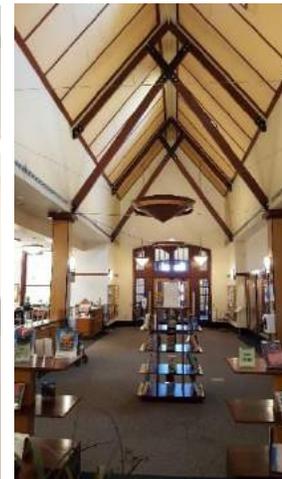
Public Circulation – A mixture of suspended direct/indirect bowl style pendants, decorative wall sconces and a custom catenary style vessel to indirectly illuminate the exposed beam structure. The layered lighting approach and decorative fixture seems to meet the spaces needs along the entry axis corridor which extends from the front door to the fire place. The suspended bowls in spaces perpendicular to the entry axis appear dated and do not provide sufficient illumination. These areas include the reference seating carrels and the children’s area. These particular areas are also a concern of the library staff. [Photos Right]
