SUN PRAIRIE PUBLIC LIBRARY

ATF MEETING # 1

MEETING AGENDA

FACILITY CONDITION ASSESSMENT NARRATIVE - DRAFT
SUN PRAIRIE PUBLIC LIBRARY
MAY 2018

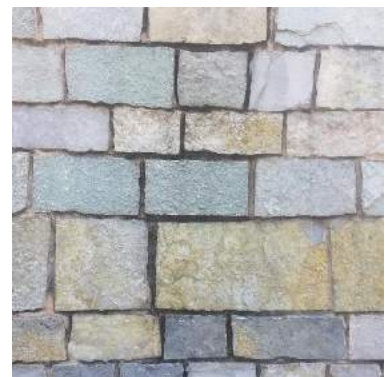
The mix of materials on the exterior create a complex aesthetic but there is little visible evidence of differential movement. There is some discoloration on the stone and mortar, which is mostly due to weathering and natural dirt build up. Cleaning the stones with as mild a solution as possible is a good way to both keep them looking good, but also to keep them safe from deteriorating due to oil and dirt residue. There are minimal instances of rust visible at masonry cracks; this

should be repaired. There are a few instances around the chimney where mortar is missing or deteriorated; this should be repointed.

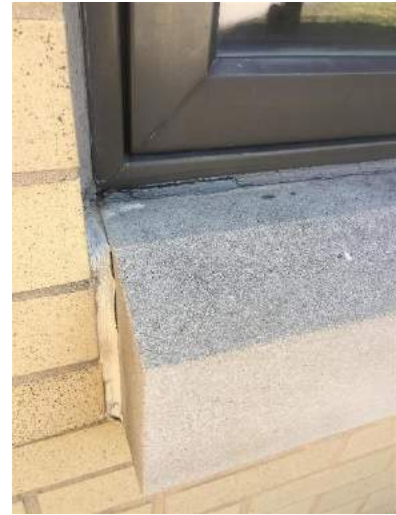
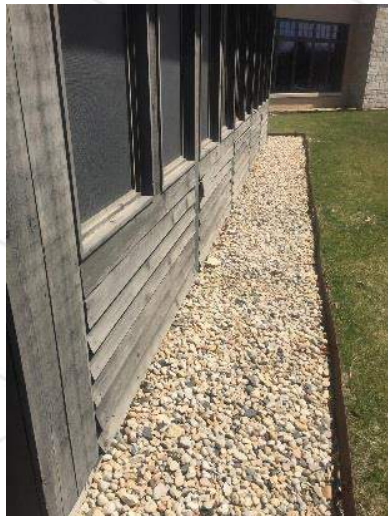
Sealant around windows and doors is cracking and contracting. It is at the end of its expected life and should be replaced at all exterior locations. There are some locations of pipe penetrations that are not sealed at the exterior, allowing entrance to pests and moisture; these should be sealed.

The porches provided on the west and east sides of the building have cedar siding and a cedar-trimmed fascia. This has weathered and has started cupping, with nails sticking out. The boards should be re-fastened and replaced if necessary. The stain finish has also deteriorated due to exterior exposure and should be reapplied. If these porches were to be occupied year-round, new siding material should be provided, they would require little structural modification, and should be evaluated for egress and code compliance.

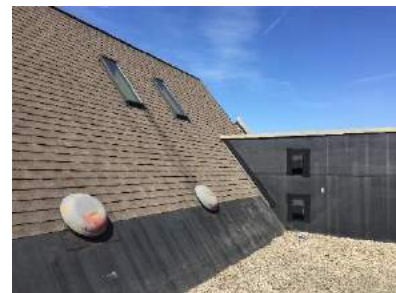
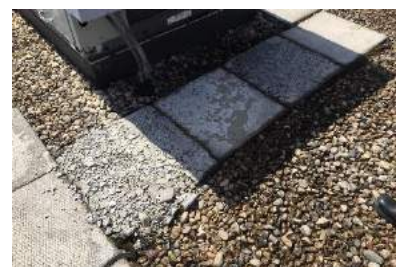
The existing roof is a mix of forms and materials. The gables are asphalt shingles, cement tile roofing, copper standing seam roofing, with copper flashing and stone copings. The low slope roof quadrants that house mechanical equipment are covered with black EPDM roof membrane. The gable roofing portions are weathering well, but the roof membrane is nearing the end of its life expectancy. The sealant seams are contracting and in need of replacement. There are some punctures in the membrane that could allow water infiltration; these should be sealed. Exposed roof termination bars should be re-sealed. The walkway pavers are deteriorating and spalling, which is interrupting the water path to the roof drains and allowing water to pond. It is expected that fixes will help maintain the roof for a few

more years whereupon it should be replaced. A non-ballasted system is recommended with a light-colored membrane with a long warranty.

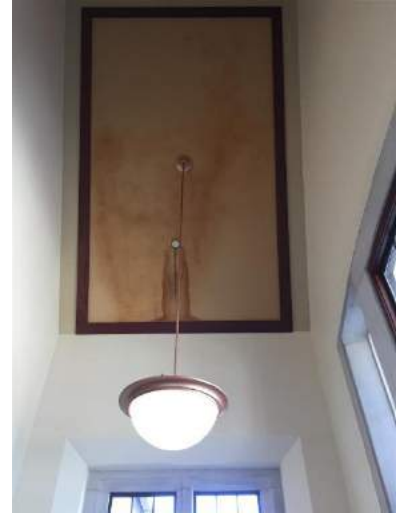
There is evidence of water infiltration in the main entrance vestibule. The acoustical fabric in the gable is stained and becoming unglued. There are instances around the building where the fabric in the gables is loose and bubbling. This should be evaluated in closer detail to verify the substrate is sound and the fabric re-adhered.

Door hardware now requires free egress, so when an occupant exits a space, the person does not need to make more than one motion to exit or unlock a door to exit a space. The existing door exit hardware does not provide proper egress at the media center main doors.

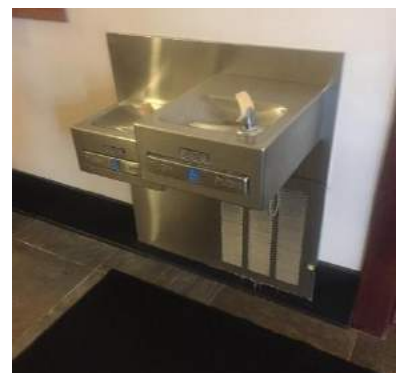
All publicly accessed water fountains are required to be installed in pairs at two mounting heights to allow for occupants of different reach ranges to use them. The current drinking fountains at the main entrance and the children's area are in pairs, but they are mounted in the path of egress travel, protruding too far from the face of the wall into the corridor. The drinking fountain in the Media Center is not accessible.

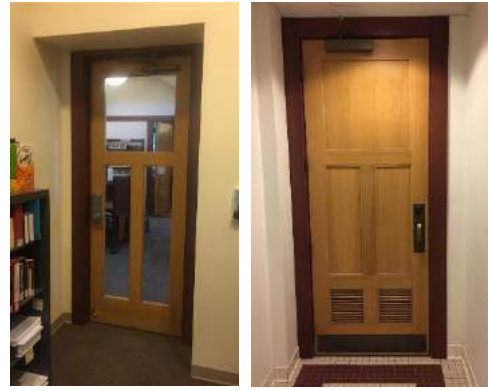
Generally, all doors in use by the public must have 1'-0" of clearance beside the door on the push side and 1'-6" on the pull side. There are instances of insufficient clearances adjacent to doors, specifically in the bathrooms and the door exiting the staff area. Proper clear space is also required where walls are greater than 8-inches thick. The exterior walls and acoustically-rated walls have door frames that are justified to the exterior plane of the wall, resulting in insufficient clearances at doors in the community room, the exterior, and the back entrance to the media center.

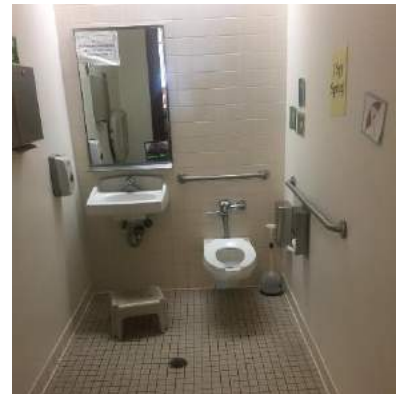
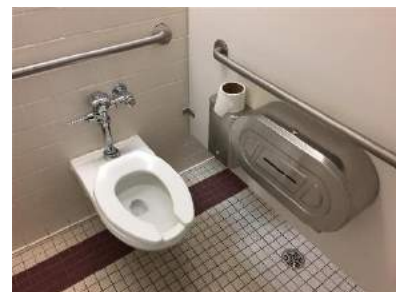
None of the six toilet rooms are fully accessible. Accessibility is not only the large toilet stall, but also includes the door clearances, grab bar locations, clear space in front of the sink, maneuvering spaces, and toilet accessories. The public bathrooms do not have the proper door clearances, insufficient space is provided between the stalls and the edge of the vanity, are missing a grab bar installed vertically above the 42" bar on the wall parallel to the toilet. The toilet paper dispenser protrudes too far into the accessible stall clear area. The staff toilet rooms are not required to be accessible since they are not open to the public. But, they do not have sufficient space around the toilet. The media center toilet room and youth toilet room are too small, without the proper clear space, improper grab bar sizes, and toilet accessories mounted too high. Shrouds are also required at piping below the sink.

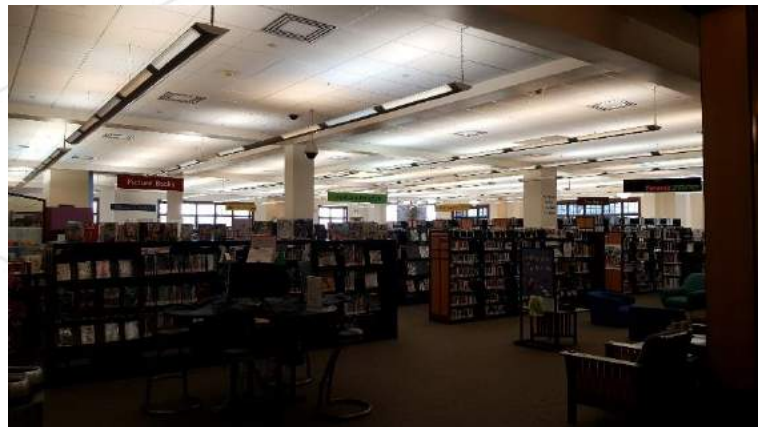
Stacks – Suspended direct/indirect fluorescent with T8 lamps. Fixtures are in good condition. Illumination levels within the stacks is appropriate and consistent with current illumination standards. Lamp color temperature (CCT) is varied unintendedly and very noticeable against the ceiling. It is likely the case of those replacing the lamps being unaware of the differences associated with CCT values. [Photo Right]

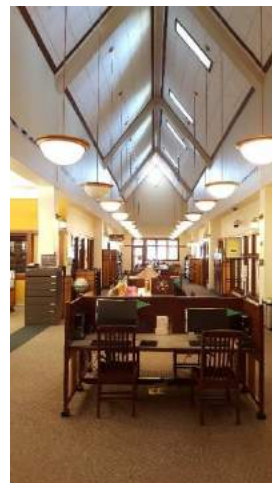
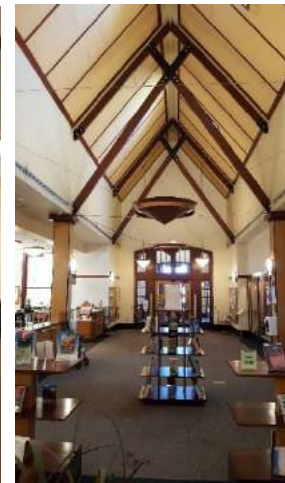
Public Circulation – A mixture of suspended direct/indirect bowl style pendants, decorative wall sconces and a custom catenary style vessel to indirectly illuminate the exposed beam structure. The layered lighting approach and decorative fixture seems to meet the spaces needs along the entry axis corridor which extends from the front door to the fire place. The suspended bowls in spaces perpendicular to the entry axis appear dated and do not provide sufficient illumination. These areas include the reference seating carrels and the children’s area. These particular areas are also a concern of the library staff. [Photos Right]
